**DEPARTMENT OF TRANSPORTATION**

Contract #: 04-0120F4Cty: SF/ALA Rte: 80 PM: 13.2/13.9File #: 1.28**WELDING INSPECTION REPORT****Resident Engineer:** Casey, William**Address:** 333 Burma Road**City:** Oakland, CA 94607**Report No:** WIR-026684**Date Inspected:** 10-Nov-2011**Project Name:** SAS Superstructure**OSM Arrival Time:** 700**Prime Contractor:** American Bridge/Fluor Enterprises, a JV**OSM Departure Time:** 1730**Contractor:** American Bridge/Fluor Enterprises, a JV**Location:** Jobsite**CWI Name:** As noted below**CWI Present:** Yes No**Inspected CWI report:** Yes No N/A**Rod Oven in Use:** Yes No N/A**Electrode to specification:** Yes No N/A**Weld Procedures Followed:** Yes No N/A**Qualified Welders:** Yes No N/A**Verified Joint Fit-up:** Yes No N/A**Approved Drawings:** Yes No N/A**Approved WPS:** Yes No N/A**Delayed / Cancelled:** Yes No N/A**Bridge No:** 34-0006**Component:** SAS OBG**Summary of Items Observed:**

# WELDING INSPECTION REPORT

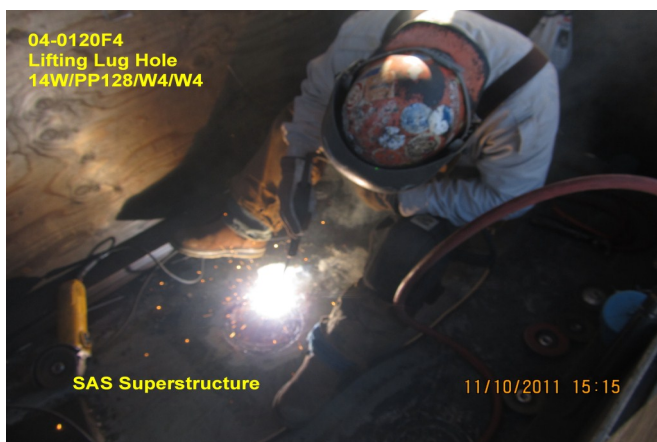
This QA Inspector randomly observed ABF welder Jorge Lopez (Welder ID 6149) performing the Shielded Metal Arc Welding (SMAW) process in the (1G) flat position on "A" deck lifting lug hole 14W /PP128/W4/W3. This QA Inspector observed QC Inspector Sal Merino verify that the preheat temperature was at the minimum of 10 degrees C and that the welding parameters (Amps=270) were in accordance with ABF-WPS-D15-1050A-CU. This QA Inspector made subsequent observations throughout the shift to monitor quality and noted that the work was completed on this date and appeared to be in general compliance with the approved WPS and the contract specifications.

This QA Inspector observed QC Inspector Sal Merino utilize a Bridge Cam Gage to measure the fit-up of the 20 mm plate in the BU-4a joint on lifting lug hole 14W/PP128/W4/W4. This QA Inspector verified the fit-up as acceptable and employed a 65°C Tempilstik to ensure the minimum pre-heat temperature had been achieved. This QA Inspector randomly observed ABF welder Jorge Lopez (welder ID 6149) performing the Shielded Metal Arc

Welding (SMAW) process in the (1G) flat position and observed the QC Inspector verify the welding parameters were in accordance with the above mentioned WPS. This QA Inspector made subsequent observations throughout the shift to monitor quality and noted that the work was completed on this date and appeared to be in general compliance with the approved WPS and the contract specifications.
